Northern States Power Company

MONTICELLO NUCLEAR GENERATING PLANT
Docket No. 50-263 License No. DPR-22

LER 97-013
Manual Scram Inserted Due to Loss of Condenser Vacuum
Caused By Electrical Fault Tripping Recombiners

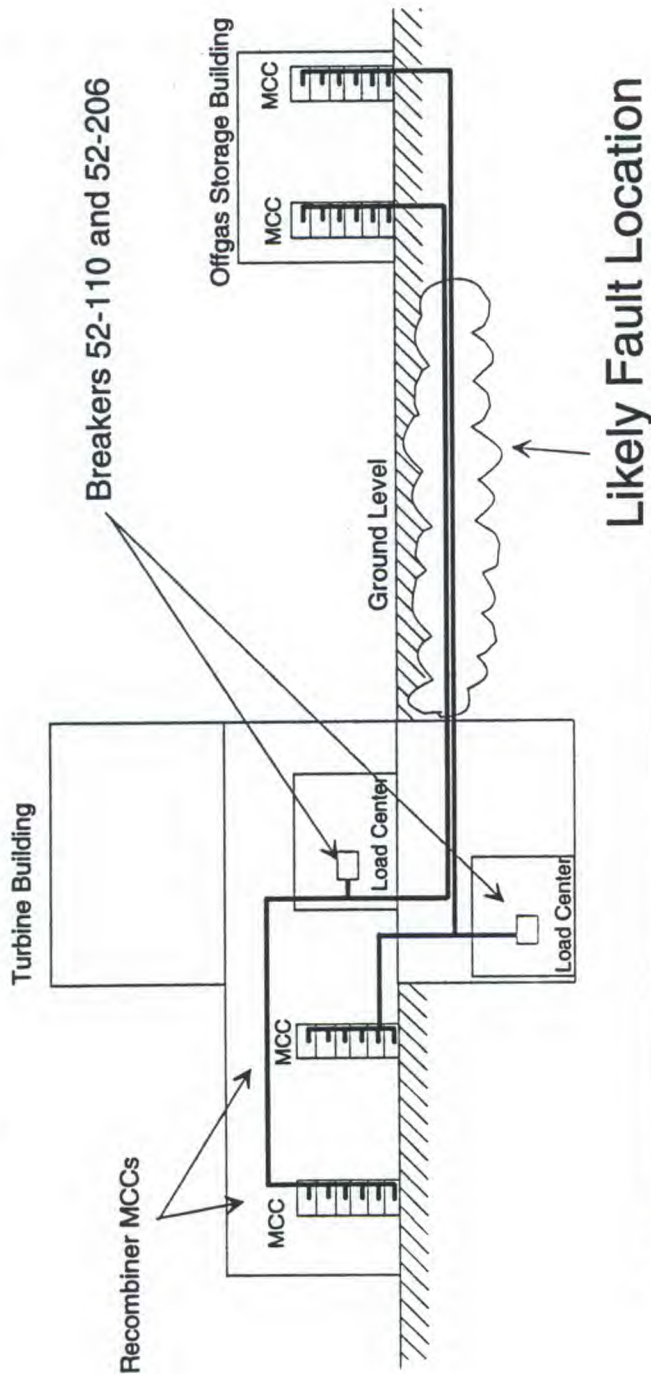
Sketch of Fault Location

On November 25, 1997, control room operators received alarms from the tripping of two 480V load center breakers¹. Each breaker fed one division of the Offgas Recombiners² and the Offgas Compressors³ plus associated equipment (see attached sketch). Loss of the Condenser Offgas System, specifically the recombiners, caused condenser vacuum to decrease. Control Room operators decreased reactor power to reduce the rate of loss of condenser vacuum. Engineering and operations personnel determined that the breakers had tripped on short circuit. Since it would not be possible to re-energize the offgas recombiners, condenser vacuum would continue to decrease. Control room operators conservatively manually scrammed the reactor (inserting the control rods).

The computer records show that both breakers tripped at the same time. The breakers are located on different elevations. Short circuit flags were activated on both breakers. These facts indicate that a common fault tripped the breakers.

The location of the electrical fault could not be determined. Cables⁴ from both of these breakers supplied non-safety related equipment in the Offgas Storage Building. They traveled underground from the Turbine Building to the Offgas Storage Building (over 1000 ft in length). A problem with the underground cabling was suspected. The cables are not fully separated when underground, allowing a cross division fault. The following actions were taken:

The testing could not determine the location of the fault. No reduced resistance was found between the two divisional cables. No low resistance, representative of a fault, could be measured between the cables and ground. However, the sandy soil around the plant can provide excellent resistance in the absence of water.

The cause is assumed to be a cross divisional fault in the underground section of the cables. The energy released during the fault (6,000 amperes) must have eliminated the fault by vaporizing moisture and/or the part of the conductor.

Temporary cables were installed primarily above ground. Where vehicular traffic was required, the cables were buried in conduit. The temporary cables feeding the Offgas Storage Building will be replaced with permanent underground cables.

An evaluation of the action necessary to ensure the proper functioning of existing plant underground cables will be conducted.
